# STABILITY OF STRUCTURE FOLLOWING BIRD STRIKE

TECHNICAL REPORT

**TECHNICAL REPORT  
ADS - 60**

**This report was prepared by NAFEC  
under Project 510-004-06X for the  
Aircraft Development Service**

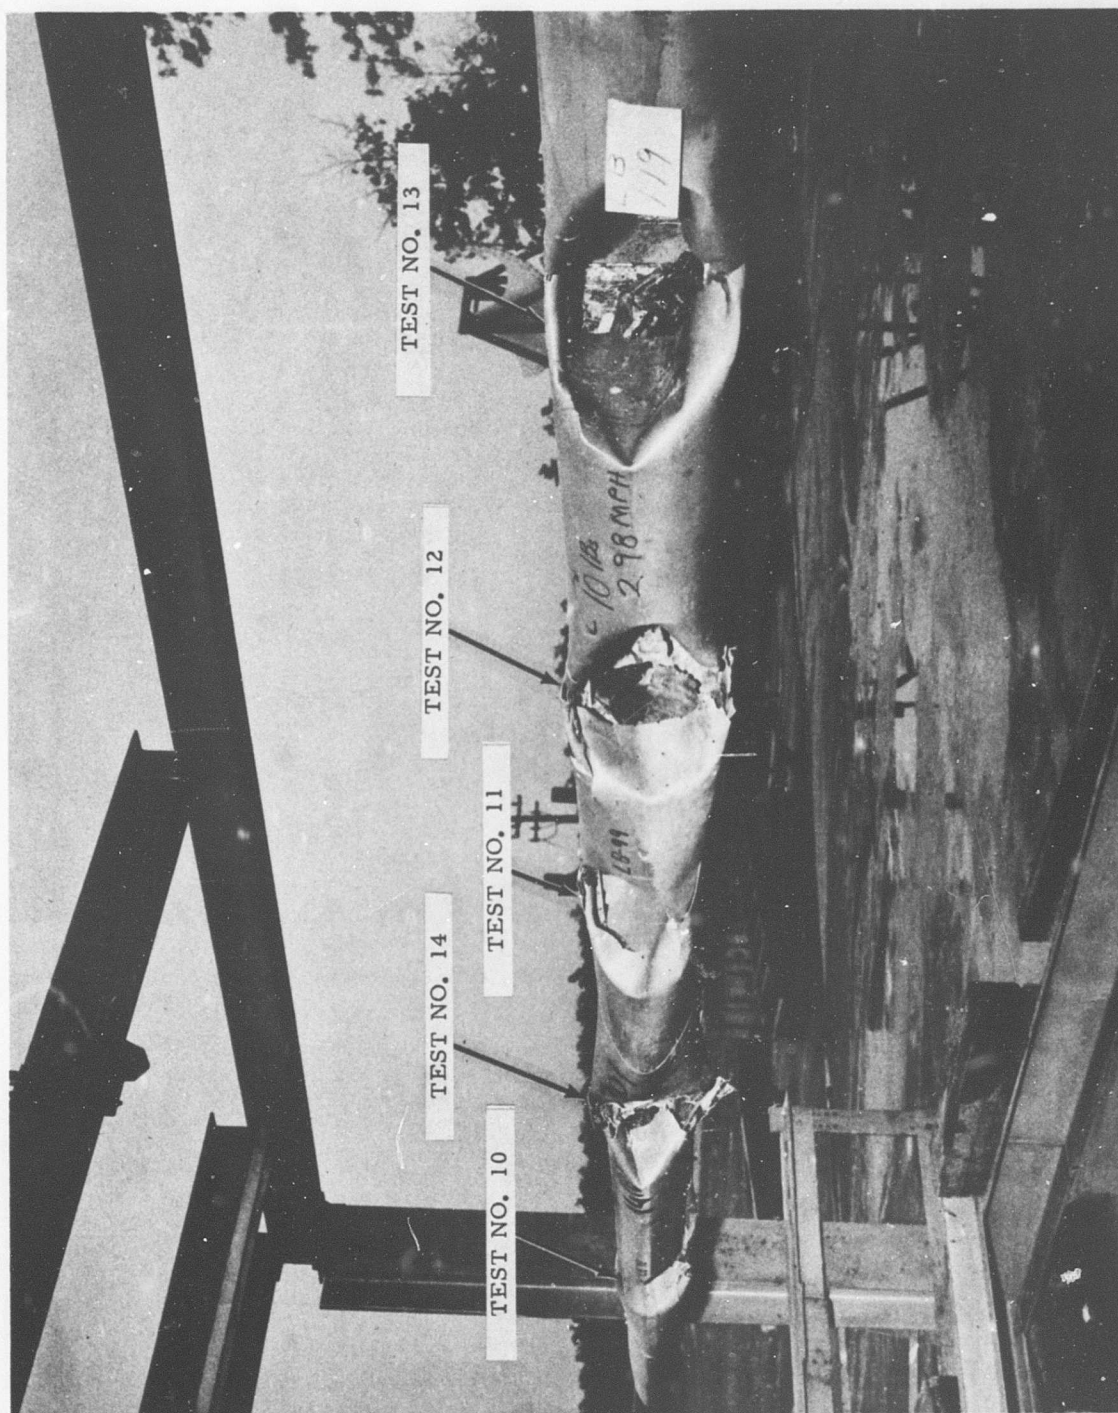
FIG. 2 BIRD STRIKE RESULTS ON SECOND TEST SPECIMEN OF A  
PISTON-ENGINE TRANSPORT HORIZONTAL STABILIZER

The effect of speed reduction on bird impact vulnerability was also investigated. Eight bird strikes, at the "turbulence penetration speed" of the airplane, were made on the third test specimen. The first two strikes were with eight-pound birds which did no damage to the leading edge at these lower impact speeds. The third strike was with a ten and one-half-pound bird and the structure withstood this strike at the lower speed of 156 mph., whereas the same size bird caused structural failure at 298 mph. None of the other bird strikes, made on this test specimen at the slower turbulence penetration speeds, caused critical damage except the last two which were birds weighing 14.2 pounds. The carcass of these larger birds would not physically fit between the spar caps which resulted in distortion and fractures of the spar caps as shown in Figures 3 and 4.

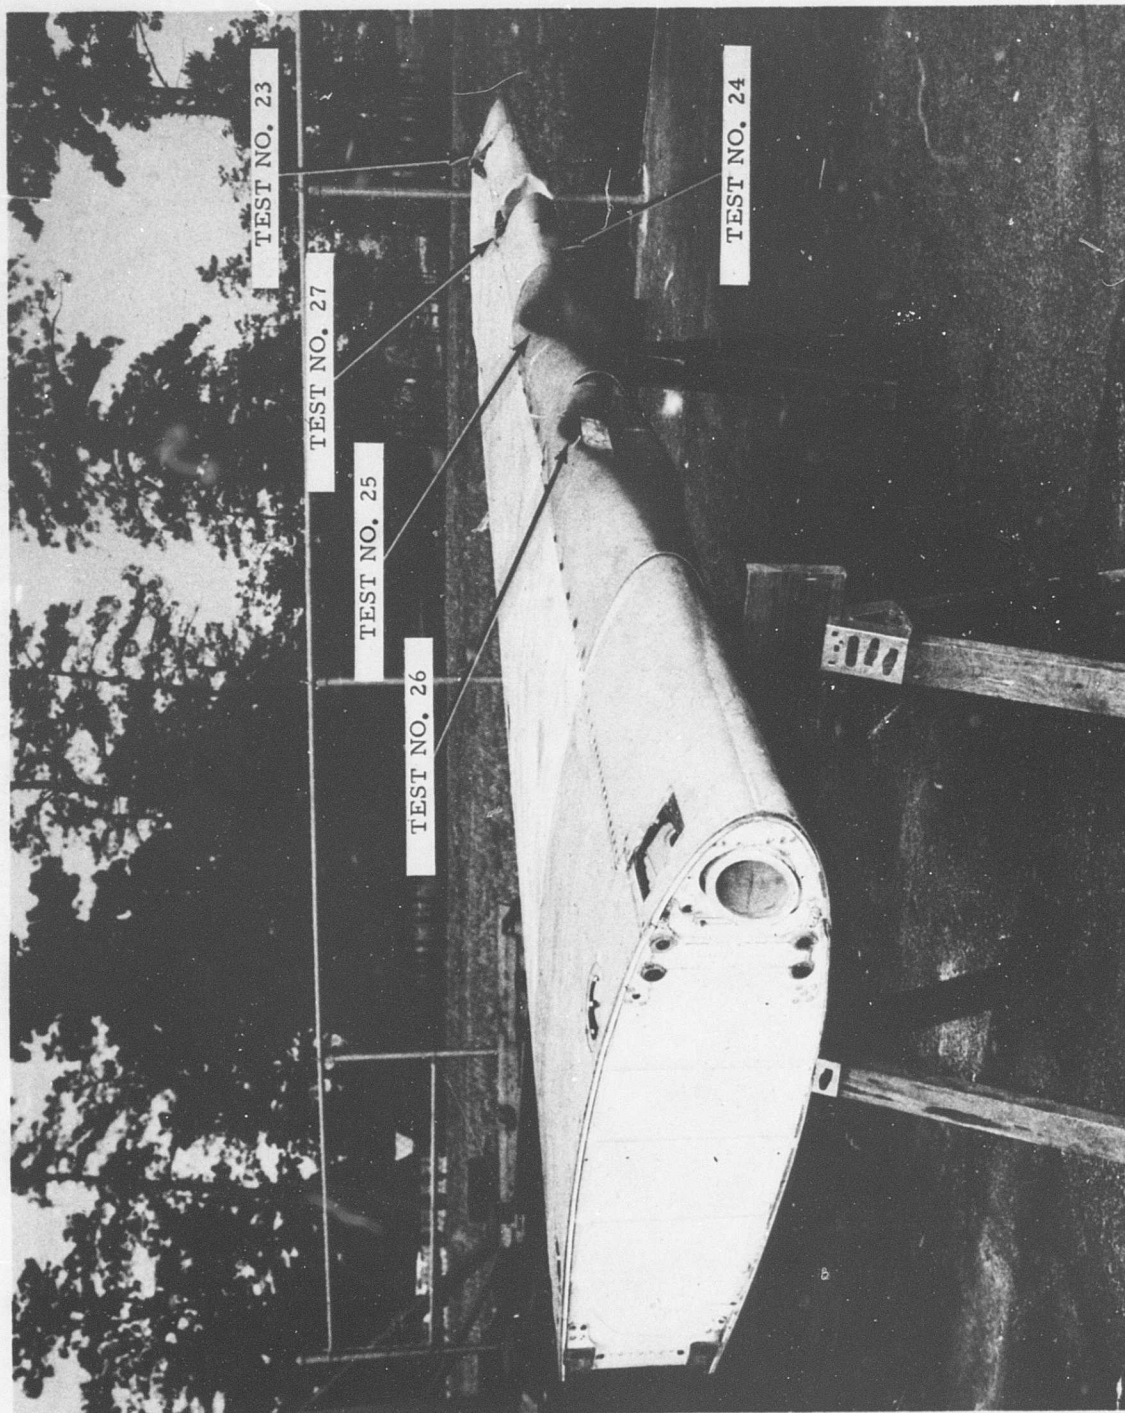
FIG. 5 BIRD STRIKE RESULTS ON A MODIFIED HORIZONTAL STABILIZER  
OF A PISTON-ENGINE TRANSPORT AIRPLANE

In an effort to decrease the vulnerability of the horizontal tail surface to bird strike damage, several modifications to the leading edge were incorporated. Table II contains a summary comparison of the results of the bird strikes made against the modified tail surface as well as the unmodified one, and Figure 5 shows the modified stabilizer after the bird strike tests had been completed on it.

An aluminum structural angle splitter was installed behind the leading edge of the tail surface where Test No. 23 was made. The impact load taken up by the structural angle was transmitted to the outboard support and then to the spar caps to which the support was attached. This load transfer to the spars caused them to be severely distorted and the failure of the weld, which connected the structural angle to the support, allowed the structural angle to sweep back in an arc and tear out more of the internal structure than was the case for the unmodified structure. It was judged that this modification actually increased, rather than decreased, the vulnerability of the structure to bird strike damage.

The leading edge section on which Test No. 25 was made had a stainless steel doubler 0.100 inch thick, and a plastic foam filler in the D section of the leading edge. The stainless steel doubler successfully stopped the bird from penetrating the leading edge. Since the stainless steel doubler was attached to the front spar caps by a row of bolts, the impact energy was transferred from the doubler to the rest of the structure through several points and there was no localized failure of the structure, as was the case on Test No. 23.

For Test No. 26 the section of the leading edge had an 0.100 inch stainless steel doubler backed up by an aluminum structural angle. The modification prevented the bird from penetrating the leading edge. The impact load was transferred from the stainless steel doubler to the front spar caps and there was some buckling of the external skin, but the structural strength of the surface was not seriously affected by this bird strike.

On Test No. 27 the section had the original standard aluminum leading edge backed with a plastic foam filler. The bird penetrated the leading edge, distorted the front spar caps, and passed completely through the rear spar web. This modification was completely ineffective and this bird strike caused structural failure just as it did on the unmodified tail surface.

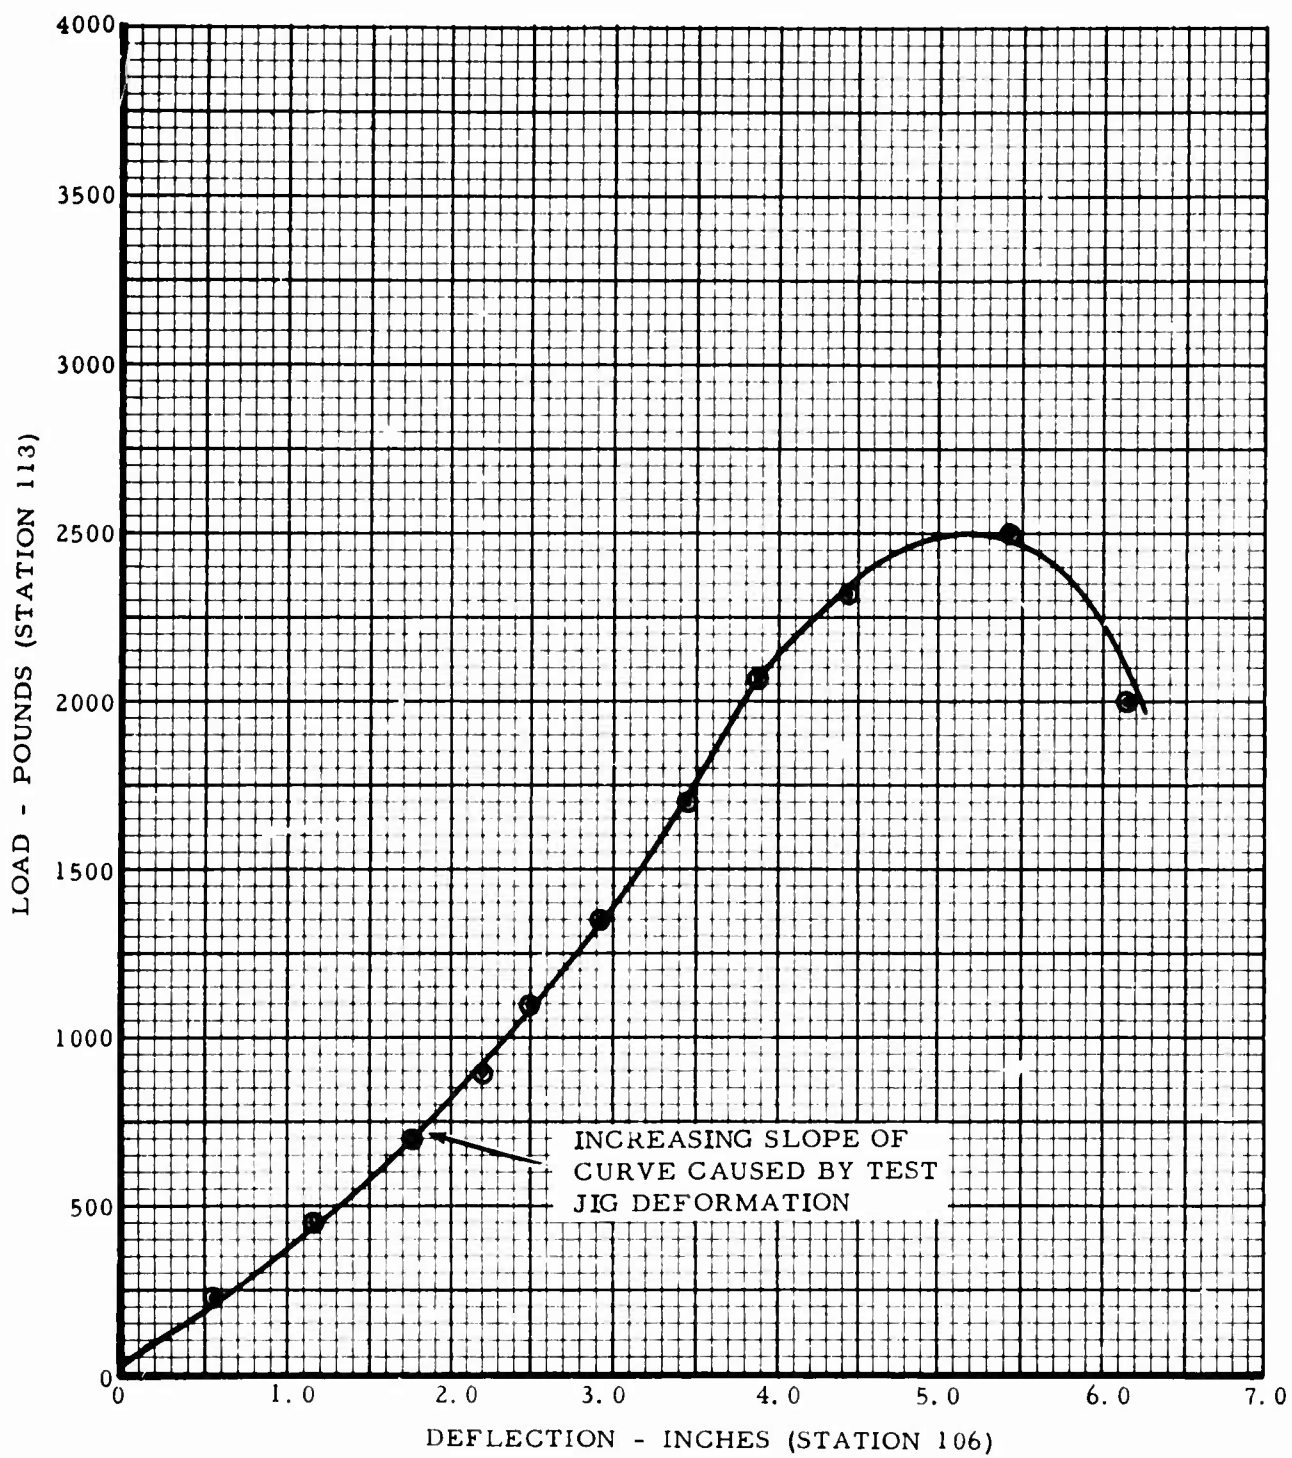
FIG. 7 RESULTS OF LOAD-DEFLECTION TEST MADE AFTER TEST NO. 32  
ON A TURBOPROP TRANSPORT HORIZONTAL STABILIZER

The structural integrity of the tail surface was not impaired by any of these strikes except Test No. 32. On this last one the bird went completely through the stabilizer, cut the elevator in two and tore off the elevator trim tab. The spar was severely damaged and the tail surface lost all structural strength. Figure 6 is a load-deflection curve of Test No. 31 and is representative of the three previous strikes where structural failure did not occur. Figure 7 is a plot of the load-deflection data taken after Test No. 32 where the deflection increased with decreased load indicating structural failure of the stabilizer.

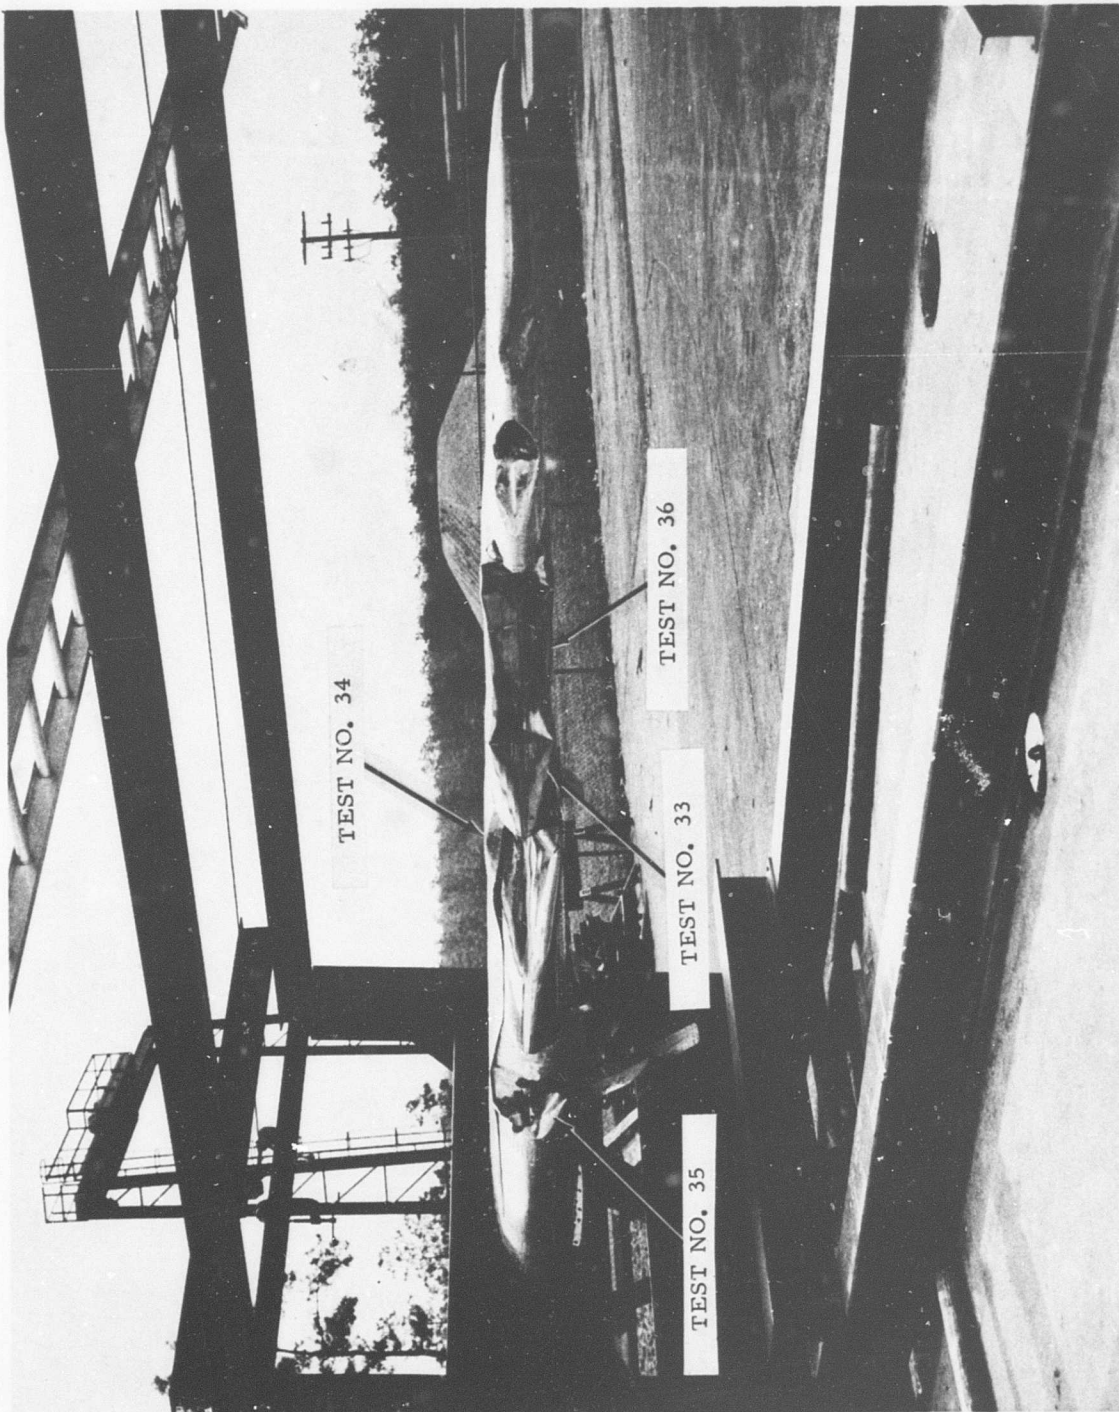
FIG. 12 HORIZONTAL STABILIZER OF A TURBOPROP TRANSPORT  
AIRPLANE AFTER BIRD STRIKES

Figure 12 is an overall view of the modified stabilizer after it had been struck by the four birds. The modifications were effective in preventing bird penetration but the energy of impact was transferred to the structure behind the leading edge, causing it to buckle. The modifications prevented bird penetration and therefore, protected the rear spar, which is the main structural member of this type of airfoil construction.

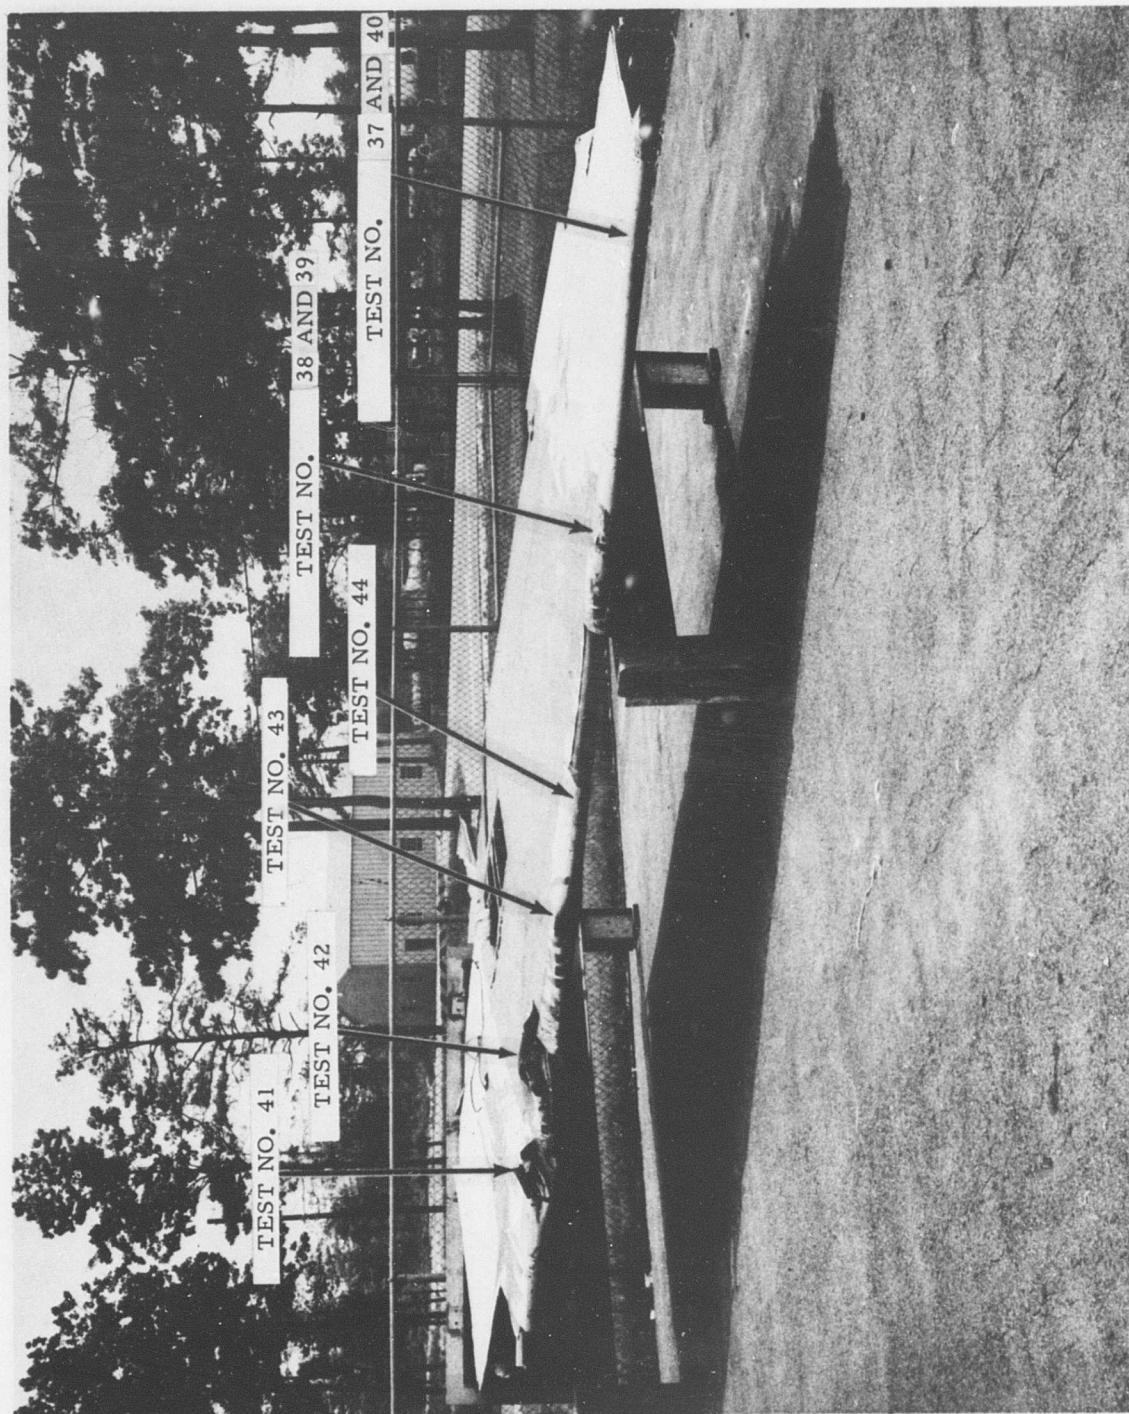
FIG. 13 VERTICAL STABILIZER OF A JET-TYPE TRANSPORT AIRPLANE  
AFTER BIRD STRIKES

Bird strikes were made against a vertical stabilizer and a horizontal stabilizer of a modern high-speed transport jet airplane. Eight bird strikes of various weights, ranging from 11 to 14 pounds, were made on the vertical stabilizer at impact speeds of about 300 mph. Table IV is a summary of these strikes. Figure 13 is an overall view of the surface after the eight bird strikes had been made.

Tests Nos. 41 to 44 were a series of strikes made where bird weight and impact speed were kept constant but the impact locations were changed. The first shot of this series was made at the furthestmost inboard location 216 inches from the surface tip. The bird penetrated the leading edge but did not damage primary structure, and therefore, this strike did not weaken the structure. The impact point of the next shot (Test No. 42) was outboard of the last strike and the bird did not penetrate the leading edge as much. The next two strikes were successively farther outboard and leading edge penetration became less as the impact moved farther outboard on the tail surface. On Test No. 44 the impact did no damage to the leading edge. A series of four bird strikes were made on the horizontal stabilizer of the jet-type carrier transport. A summary of these strikes is given in Table V. Figure 14 is an overall view of the horizontal stabilizer after the four bird strikes had been made. On all of these strikes, the bird penetrated the leading edge and tore out internal structure and ribs before becoming lodged inside the structure. Although the birds penetrated the structure, the spar caps were undamaged and therefore, the structural strength was not impaired. It appears from the above tests that the horizontal stabilizer was not as resistant to bird strike damage as the vertical stabilizer. A ten-pound bird at about 300 mph impact speed easily penetrated the leading edge of the horizontal stabilizer at any location along its length, whereas the vertical stabilizer withstood a 14-pound bird impacting at 300 mph penetration, if the strike was made toward the

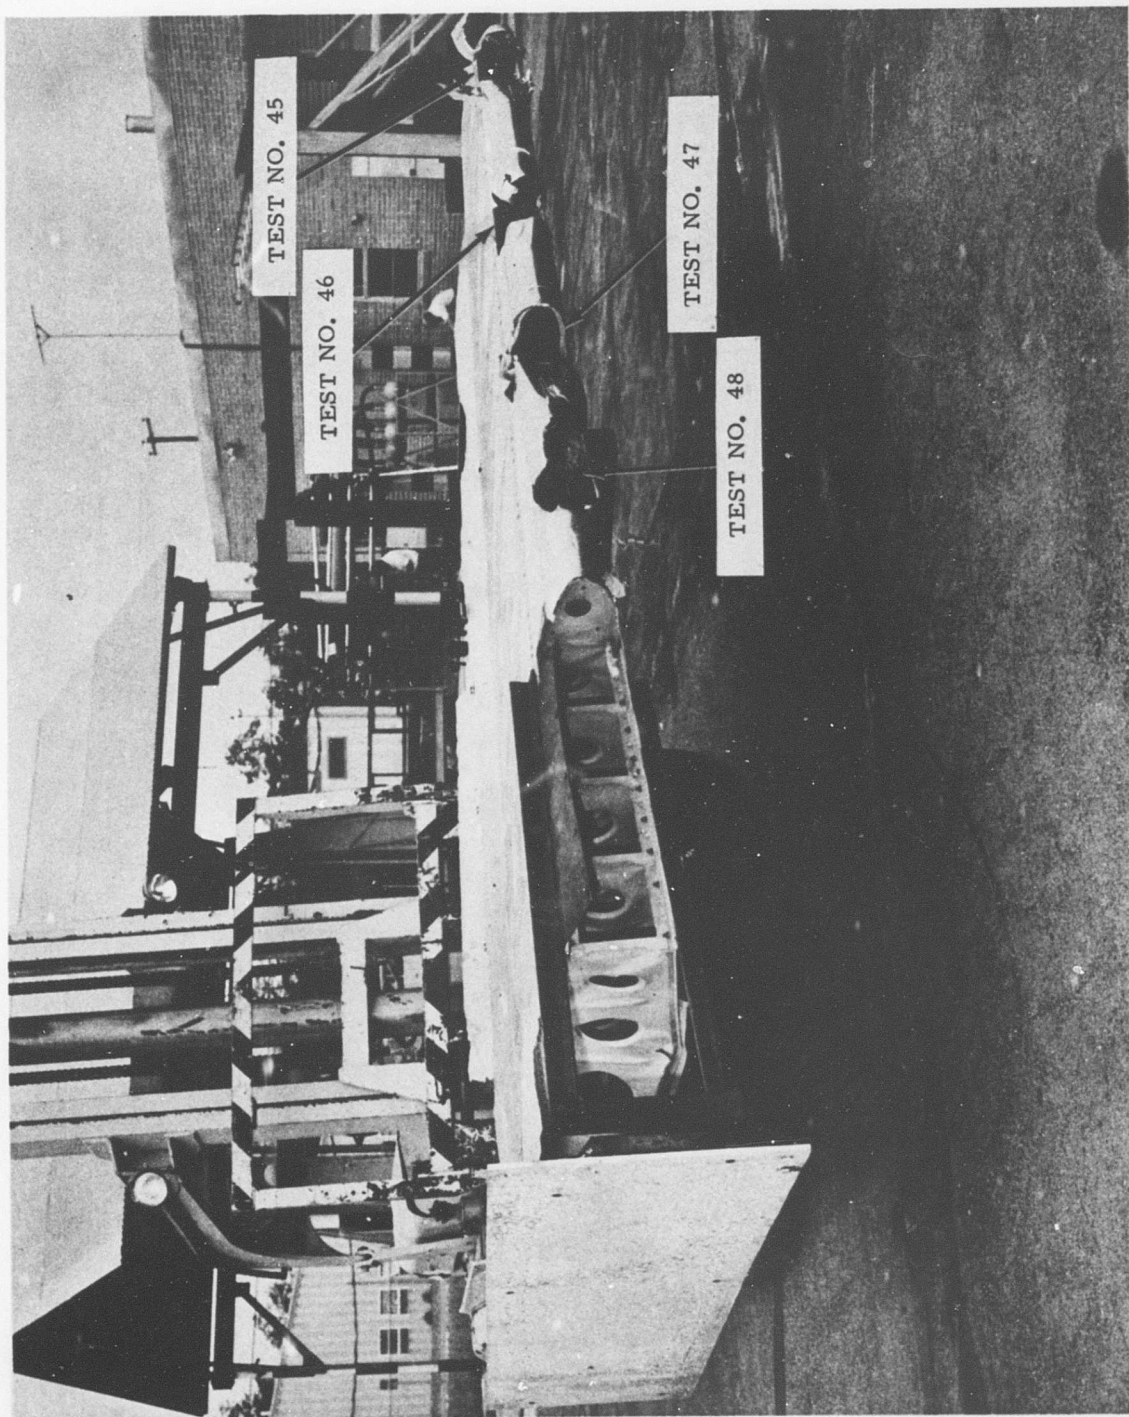
FIG. 14 HORIZONTAL STABILIZER OF A JET-TYPE TRANSPORT AIRPLANE  
AFTER BIRD STRIKES

TEST No.	BIRD WEIGHT Pounds	IMPACT VELOCITY mph	DISTANCE OF IMPACT POINT FROM TIP in	REMARKS
45	9.25	294	12	On all of these shots the bird penetrated the leading edge, tore out internal ribs, and remained lodged inside the stabilizer. Spar caps were undamaged.
46	9	304	48	
47	10	305	80	
48	10.75	300	106

outboard tip. If the horizontal stabilizer could be manufactured more along the lines of the vertical stabilizer, it appears that it might be less vulnerable to bird strike damage.
